## White Paper Overview

## Detecting integrity breaches in a range of pharmaceutical blister package types using sepha VisionScan.

**Dr. D. Dixon, University of Ulster,  
Shore Rd, Newtownabbey,  
N.Ireland, BT37 7QB  
d.dixon@ulster.ac.uk**

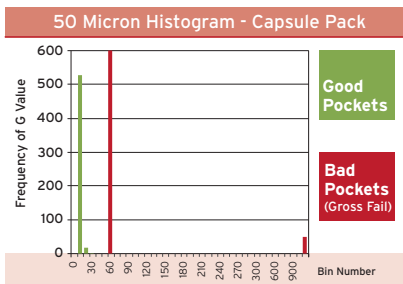
Figure 6

Distribution of G values for pockets containing either no defect or a 50µm hole (foil sealed capsule polymer pack).

Fig. 6 illustrates the distribution of G values from good packs and those with a 50µm hole. A marked difference is observed between the behaviour of the good pockets and those containing a laser drilled defect. In the case of the 50µm defects all the failures were detected due to differences in G value. All other packs tested during this study showed failure due to differences in G when looking for 50µm defects, aside from Pack type 2 which contained large round tablets. It was found that these pockets failed due to differences in D which could be down to the larger pocket volume.
